A geogrid-reinforced landslide stabilization: 20 years passed

ABSTRACT

In spring 1994 a landslide occurred on a natural slope of about 25 m height just below a ski-lift station in the Austrian Alps near Lech. The slid soil mass blocked the road at the toe of slope. The upper part of the sliding surface reached the foundation of the lift station on top of slope destroying the earth platform in front of the station and endangering the entire building.

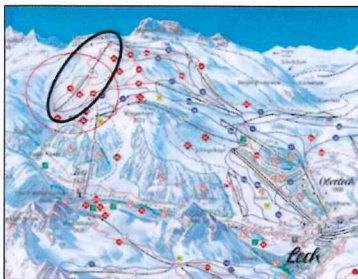
Fig. 1. The ski region of Lech in the Austrian Alps (the Steinmähder Wand is marked).

In spring 1994 a landslide occurred in a natural slope of about 25 m height just below the lower ski-lift station at the so called Steinmähder Wand (Figure 1).

This lower station is positioned at 1800 mNN, the upper one at 2300 mNN (Figure 1).

to be critical. The most probable trigger was may be a “global” over-wetting due to massive snow melting on the slopes above (Figure 1). In Figure 2 a precipitation overview is depicted.

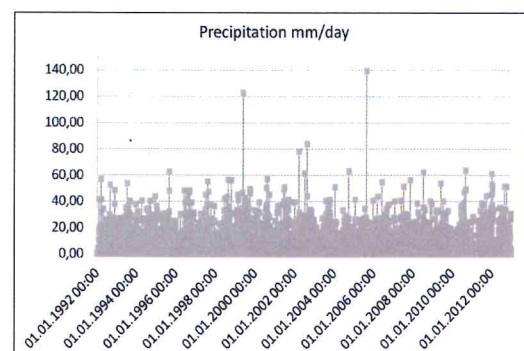
Fig. 2. Overview of precipitation.

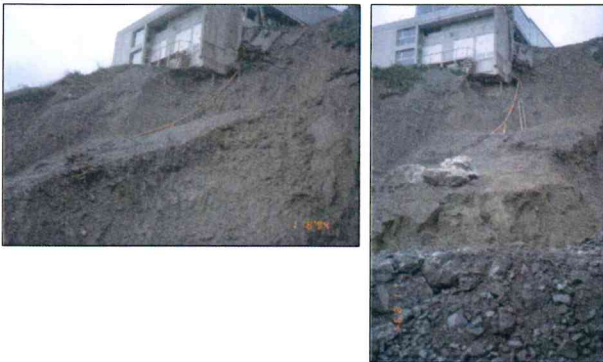
The slid soil mass blocked an unpaved but important alpine road at the toe of slope. The upper part of the sliding surface reached the foundation of the lift station on top of slope destroying the earth platform in front of the station and endangering the entire building (Figure 3) despite the micro-piles below the front part of foundation. The width of landslide amounted to ca. 50 m, the height varied from 23 to 25 m.

Fig. 3. Part of landslide with endangered lift station.

After landslide neither a soil layer as possibly pre-defined sliding plane (e.g. clay) could be visibly identified, nor concentrated wells (despite some extremely wet areas). The failure surface was three-dimensional, non-planar and quite irregular (Figure 3).

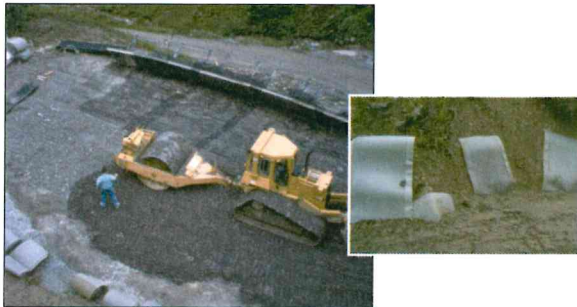
Figure 5 shows at a glance all components of the system and the compaction procedure. Note the use of heavy compaction for the 0.75 m thick fill layers and the installation of drainage mats with a space in between (Chapter 6). One can see (Figure 6) that due to

Fig. 5. Construction: first layers, fill compaction by heavy equipment, formwork, geogrids, drainage mats.

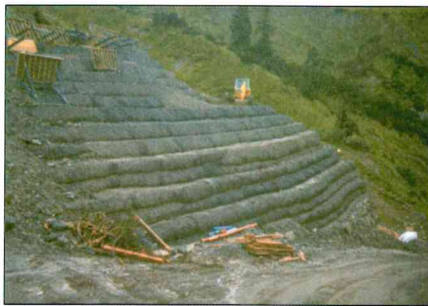
the lack of experience (the contractor had never built such a system) and the extreme time pressure the geometry of the first geogrid-soil layers was not really precise. However, because this was not critical for stability and due to the anyway intended nature-alike final shape, this was tolerated.

Fig. 6. Construction: partial view of the geogrid-reinforced slope. Note the "bellies" of the first layers.

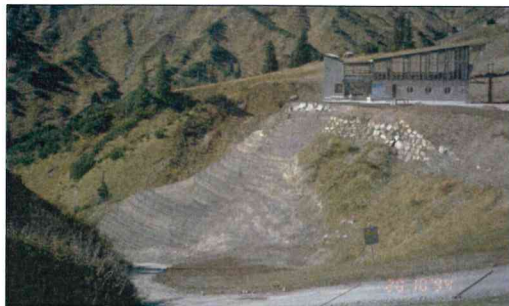
Fig. 7. Geogrid reinforced landslide stabilization just after completion (end of September 1994).

Figures 7 & 8 show the geogrid-reinforced stabilization just after completion and one year later. It should be noted that considering all the problematic factors and circumstances such a short construction time was a real achievement. It is recognizable how the adapted soft, to some extent irregular 3D-geometry fits successfully the natural alpine landscape.

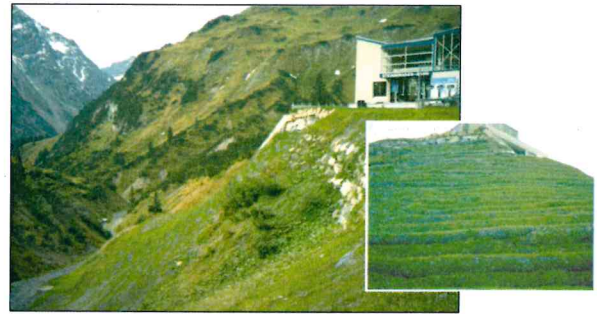
Fig. 8. The system in summer 1995, almost a year after completion and after a winter-spring cycle.

In summer 1995, after almost a year after construction and after a winter-spring cycle there were no indications of stability or serviceability problems of any type. (Note that a year ago at that time the landslide failure occurred). The hydro-seeding seemed to be quite successful although not perfect.

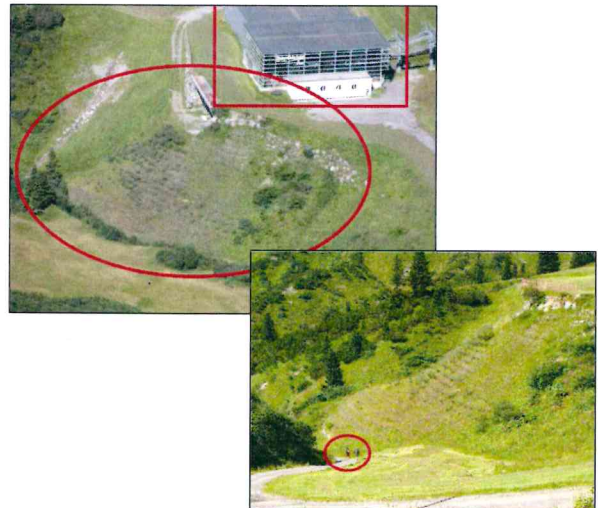
Fig. 9. August 2014: left up: overview, reinforced slope is marked; right down: persons as a scale for the structure.

Visually there were no indications of any relevant deformation of any type: neither vertical, nor horizontal. Although no precise measurements had been done over the twenty years passed, the systematic inspections of the owner had attested no problems from the point of view of stability or serviceability of the reinforced slope or of the station foundation on top.

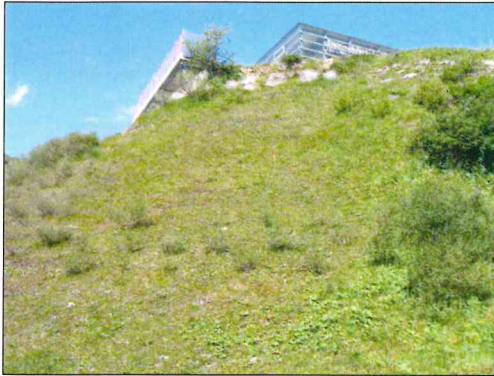
Fig. 10. August 2014: view upslope.

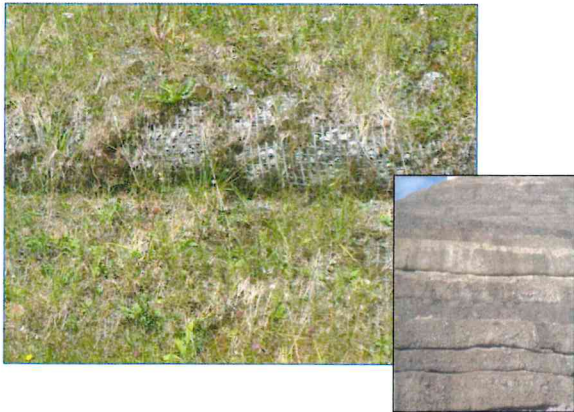
Fig. 11. August 2014: left: zoom of a vertical layer of the geogrid facing with a “belly”; right: same section in September 1994.

The facing was to more than 90 % vegetated, although only marginal maintenance had been done. In the meantime the typical local vegetation dominated the picture. The only spots with meager vegetation were the almost vertical parts of some “belly” layers (Figure 11). Some erosion of fines was visible (Figure 11) due to the missing anti-erosion geotextile behind the geogrids (decision of the owner in 1994, see Chapter 6). However, this had no further negative consequences. Note, that the completely unprotected geogrids are still intact.
