Asphalt Reinforcement with Polyester Grids: Practical Experience in Airfields

Zehra KAYA ¹, Fabiana LEITE-GEMBUS ²

1. *Huesker Australia, Brisbane, Australia*
2. *Huesker Synthetic GmbH, Gescher, Germany*

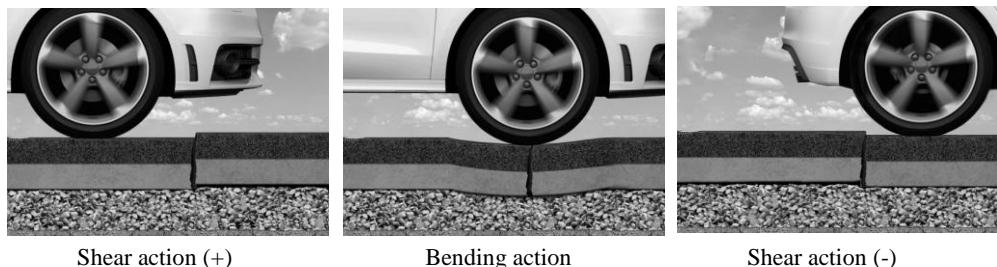
FIGURE 1 Critical Loading Cases in a Pavement Crack

When a wheel load passes over a crack in the existing pavement, bending and shear stresses are induced on the existing crack, causing the crack to develop further [1-6]. The shear action occurs twice by each load application, while the bending action occurs only once (Figure 1).

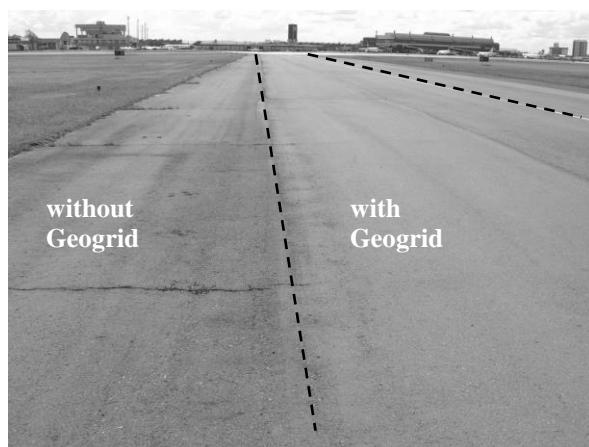
FIGURE 5 Overview of the Studied Section: View of the Taxiway to the Maintenance Hangar

In October 2007, approximately 7 years after the rehabilitation, the first assessment of the pavement took place. At that time the Designer, the Airport Technical Manager, and a Representative of the reinforcement manufacturer were present. The expansion joints in the concrete below the unreinforced pavement sections were found to have propagated to the top of the surfacing aggressively. The vegetation, visible in the developed cracks, led to the conclusion that these cracks had existed for some time. In contrast, the areas reinforced with the PET-grid did not show cracking (Figures 5 and 6).

This first visual assessment was followed by a detailed evaluation of the pavement to examine and confirm the effect of the high modulus PET-grid reinforcement in significantly delaying the crack propagation as seen in Figure 5 and 6.

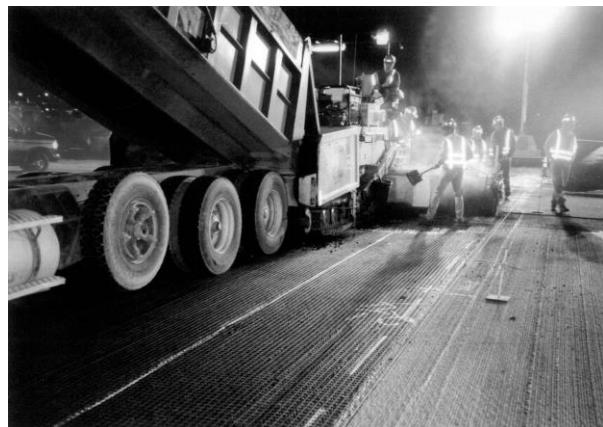
FIGURE 7 Installation of the Polyester Reinforcement Grid In 2000

The project specification required milling of the existing pavement, applying the asphalt reinforcement over the milled surface, and constructing a new asphalt overlay. Because of its flexibility and exceptional resistance against shear stresses, it was possible to install the polyester grid directly over the milled asphalt surface without a levelling course (Figure 7). This was extremely important to the project due to time limitations on site, with construction access to the runway between 10 p.m. and 6 a.m. only. Nightly repairs to the runway, including line painting, had to be completed by 6 a.m. each night. As the extra process of constructing a corrector layer was not required, works could be completed more efficiently on site, with larger areas being paved each night.

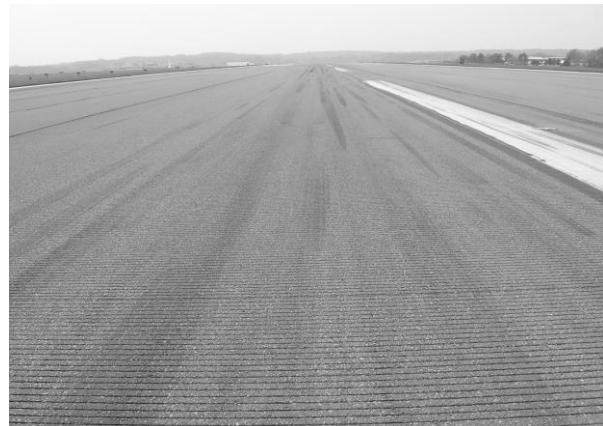
FIGURE 8 Condition of the Pavement in 2007

An inspection of the runway held in 2007 showed the pavement to be in a very good condition despite the increase in the amount of traffic and the size of the aircraft using the international airport (Figure 8). Airport officials were highly pleased with the condition of the reinforced runway pavement seven years after its installation.

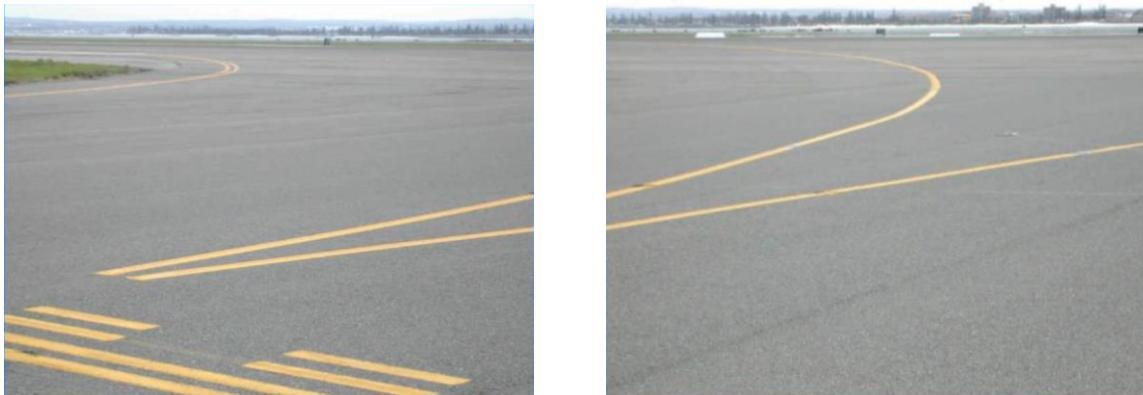
FIGURE 9 and FIGURE 10 View Looking South-West Across Runway 16R-34L From Hold Point at Taxiway Lima

In 2010, assessing authorities reported that the Sydney Airport Parallel Runway expedient pavements had been in service for in excess of 15 years and that no cracks or joints from the underlying concrete had reflected to the given date at Australia's busiest airport (Figures 9 and 10) [17].

The polyester asphalt reinforcement was incorporated within the asphalt layer in order to delay the reflection of the cracks and joints in the underlying concrete slabs through the new surface and extend the lifetime of the pavement. This is because the joints and cracks in the underlying pavement layer typically reflect through the new overlay due to dynamic / traffic loads and thermal stresses. As required, an asphalt levelling course was first placed over the concrete slabs prior to installation of the polyester asphalt reinforcement which was then covered with a minimum of 40mm asphalt overlay to complete the works.

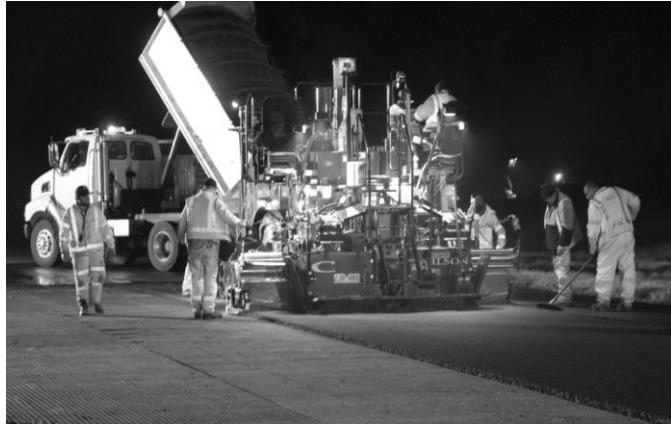
FIGURE 11 Laying Asphalt Over the Polyester Asphalt Reinforcement

Additionally, in order to mitigate the propagation of the existing concrete pavement failures into the new asphalt surface, an asphalt reinforcement made from high modulus polyester was installed between the two 50mm asphalt layers as seen in Figure 11. Works were completed overnight, between 10 p.m. and 6 a.m. The treatment area was 100m in length across the full taxiway width.
