CONCRETE PAVEMENT REHABILITATION BY USING A HIGH MODULUS POLYESTER GRID AS ASPHALT REINFORCEMENT

CASE STUDY: HIGHWAY MG-424, MINAS GERAIS, BRAZIL

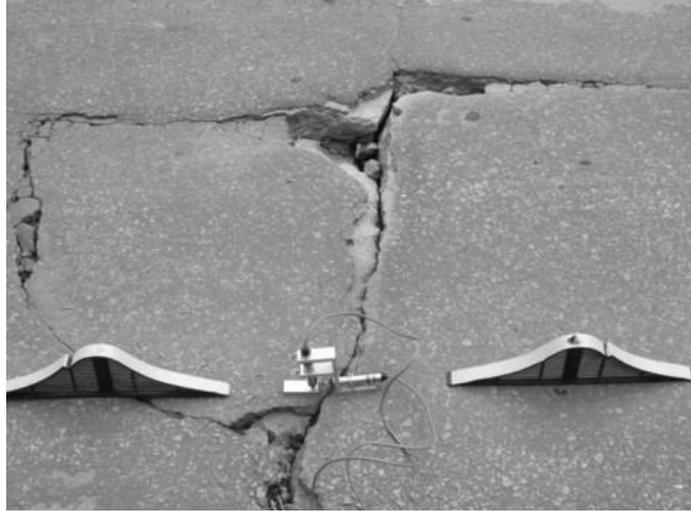
Figure 4: Crack and corner break at station 163

The displacement measurements indicated that the existing concrete pavement presented sections in better and others in worse condition. At the station 163, for example, large cracks and corner breaks could be observed, indicating a possible loss of pavement support (Figure 4).

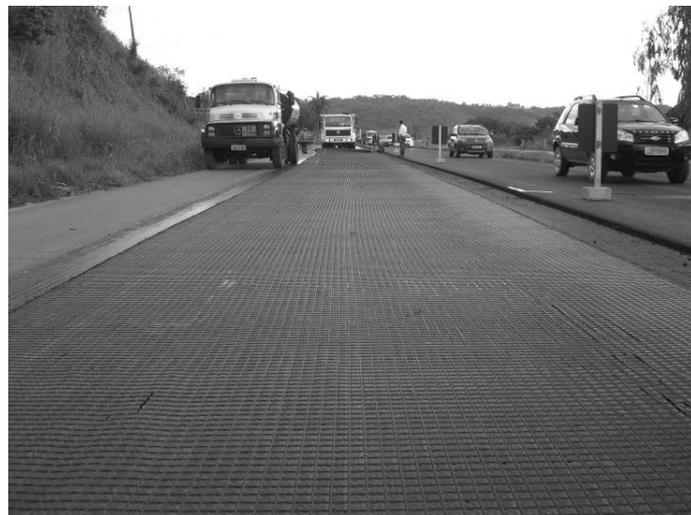
Figure 8: HaTelit® asphalt reinforcement

On April 2013, a polyester grid as asphalt reinforcement was then installed full width in accordance with the manufacturer's installation guidelines (Huesker, 2015) on the levelling layer, and was covered with the planned 50 mm asphalt surface course (Figure 8).

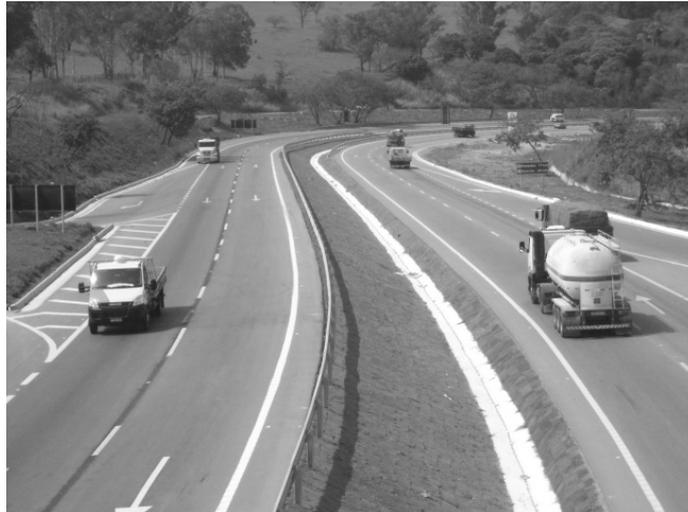
Figure 9: Highway MG-424 two years after rehabilitation

Almost two years after the rehabilitation, the reinforced area in the highway MG-424 still does not show any cracking (Figure 9). The use of a polyester grid prevented the propagation of reflective cracks developing from the expansion joints of the concrete slabs, proving to be an effective solution.
